Landslides and related features identified from aerial photographs:  
1:60,000 SCALE BLACK AND WHITE 1960  
1:125,000 SCALE COLOR INFRARED 1973  
1:80,000 SCALE BLACK AND WHITE 1975

## LANDSLIDES AND RELATED FEATURES OF THE MOUNT ALTO, W.VA.-OHIO QUADRANGLE

OPEN FILE MAP 83-80 (G-1)

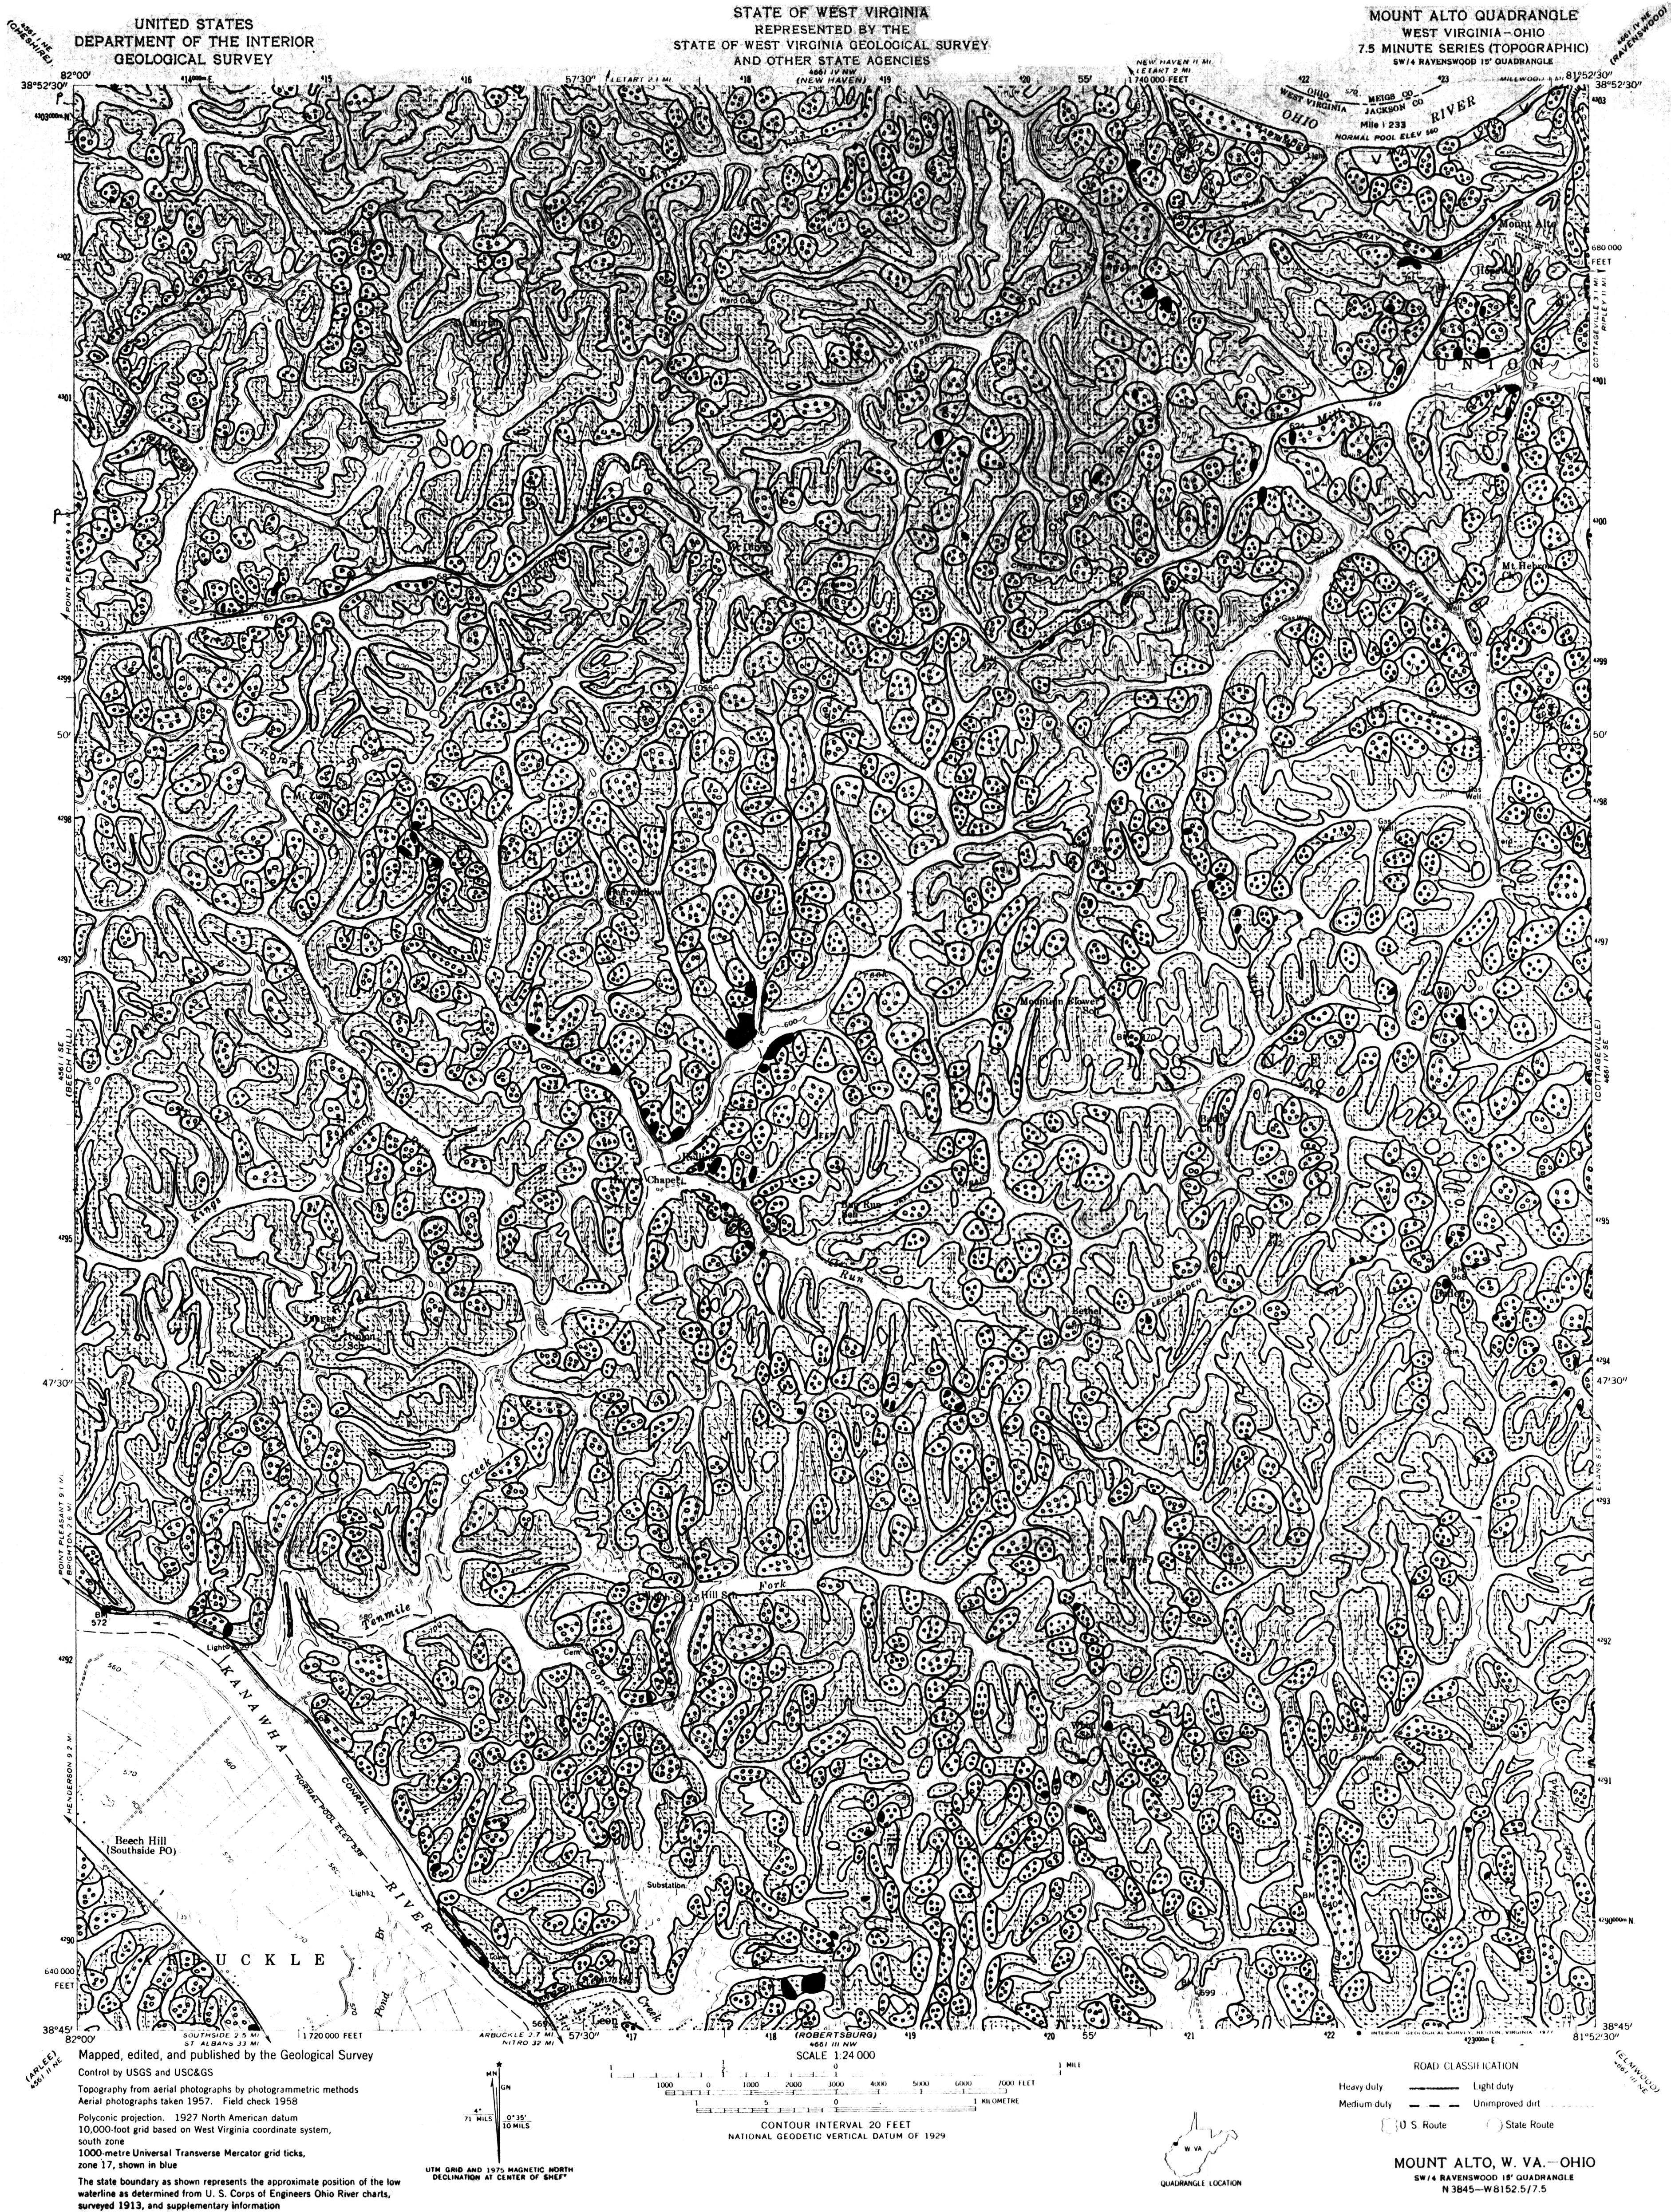
Information shown is intended as a general guide to ground conditions as of the date of field check. Additional landslides and rockfalls should be anticipated in all map units. The map unit depicts the dominant condition in the area delineated and variations in slope stability may occur at any point in the unit. This map is suitable for general planning purposes and as a supplement to more detailed studies for site selection. The map cannot be used as a substitute for detailed geologic and engineering investigations to establish design and construction criteria of specific sites. Some symbols may not appear on this map because the description is applicable to a series of maps.

**ACTIVE OR RECENTLY ACTIVE LANDSLIDE**  
Complex landslide composed of earthflow, debris slide, earth and rock slump. Identified from historical records, and from scars, debris and other field evidence. Ground extremely unstable; sliding accelerated by excavation, loading and changes in drainage conditions. May include areas with several active slides too small to be shown separately.

**OLD LANDSLIDE**  
Area of extensive hummocky ground caused by earthflow and earth and rock slump. Lacks clear evidence of active sliding. Relatively stable in natural, undisturbed state, generally not affected by small structures properly sited in areas away from the edge of the toe, can be reactivated by extensive, rapid excavation, loading, and changes in ground water and surface water conditions. Area of old landslide probably includes recent ones not identified from field evidence or otherwise documented. Upslope boundary of landslide generally defined by modified scarp, but downslope (toe) may be gradational and not well defined.

**COLLUVIAL SLOPE**  
Valley wall along major streams with slope as steep as 40° (85%); stony, clayey silt soil up to 50 ft. (15 m) thick; commonly buttressed by a terrace or bench at the toe of the slope, very susceptible to sliding by cutting of toe area, removal of terrace or bench, and overloading, slide commonly activated without apparent cause.

**AREAS SUSCEPTIBLE TO DEBRIS FLOWS AND DEBRIS AVALANCHES**  
Primarily shallow, narrow ravines and chutes with accumulation of stony colluvium generally 10 ft. (3 m) or less in thickness; susceptible to rapid movement during intense rainfall. Most ravines and chutes designated show evidence of former debris flows and avalanches. Symbols also designate historical debris flow or debris avalanche.

**AREAS SUSCEPTIBLE TO ROCKFALL**  
Steep, locally vertical, natural and man-made slopes and cliffs, 15 ft. (4.5 m) or more high; formed dominantly of sandstone, limestone, sandy shale, mudstone and claystone. Interbedded mudstone, claystone and shale weather rapidly leaving sandstone and limestone rock faces unsupported.

**SOIL AND ROCK SUSCEPTIBLE TO LANDSLIDING**  
Soil and rock similar to that involved in landslides elsewhere in map area; primarily areas underlain by claystone, mudstone and shale associated with other rock types. Rock weathers rapidly on exposure forming clayey soil highly susceptible to sliding. Includes coves (U-shaped, shallow valleys) containing thick layers of clayey soil that are very susceptible to sliding where excavation breaks continuity of slope and where overloaded by artificial fill.
